I was having some issues with the carriage feed system on my PM1340 lathe. The carriage feed system would not turn. This caused the change-gears to grind and I ended up with broken change-gear teeth. I was able to pinpoint what I believed was the culprit. Something was bound-up solid in the carriage feed shaft system.

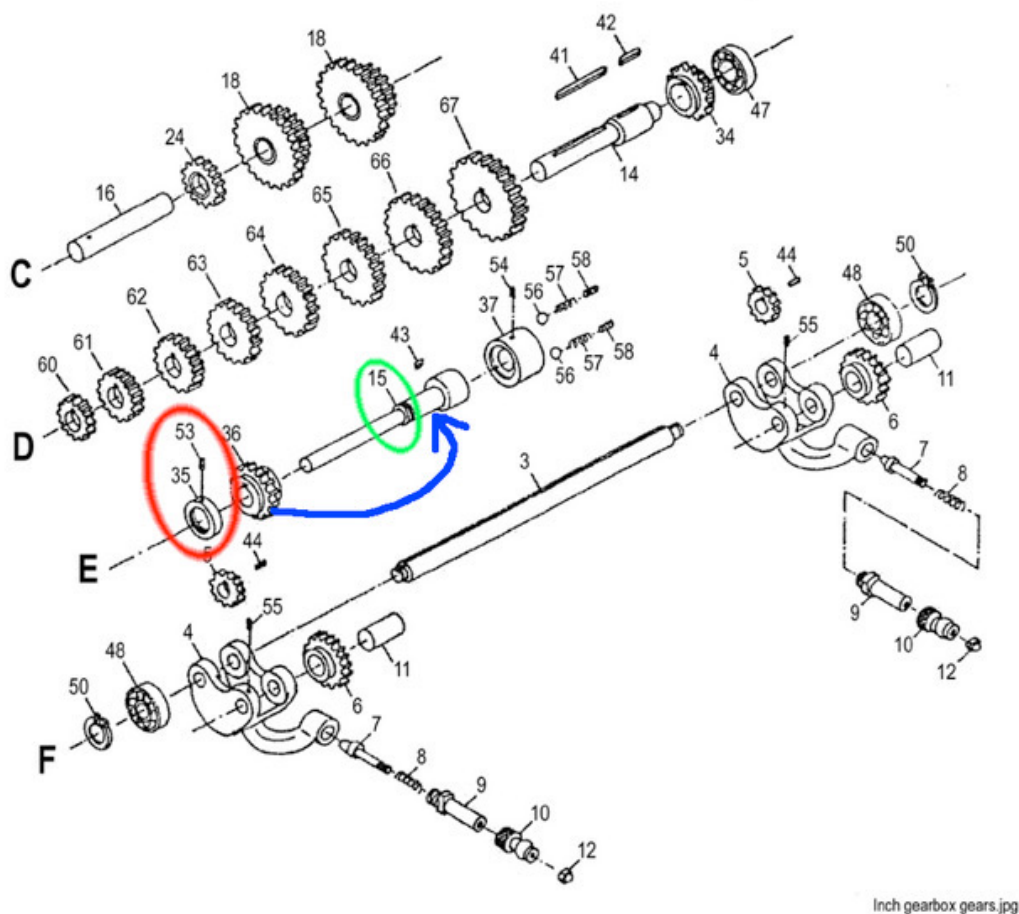
The shaft in question is "E" in the drawing. Although the drawing shows a collar with set screw (circled in red) holding the shaft in position, that element does not exist. The gear #36 sits further up the shaft as shown with the blue arrow, and a snap ring (circled in green) holds

that gear in position against the bushing in the side of the gearbox casting. The snap ring locking that gear #36 in position at the end of the shaft is what prevents the shaft from lateral movement and removal.

That shaft felt like it had been press fit into the side of the gearbox and was impossible to get out without removing the gear train in front to get access to press the shaft out. That front gear train marked "D" is held in position with a screw/washer on the outside of the gearbox holding the ball bearing #47 in position. That ball bearing is also press fit into the casting and was difficult to remove, but I did get it out. Once that front gear train was out, I had enough access to pound out the shaft that drives the feed rod.

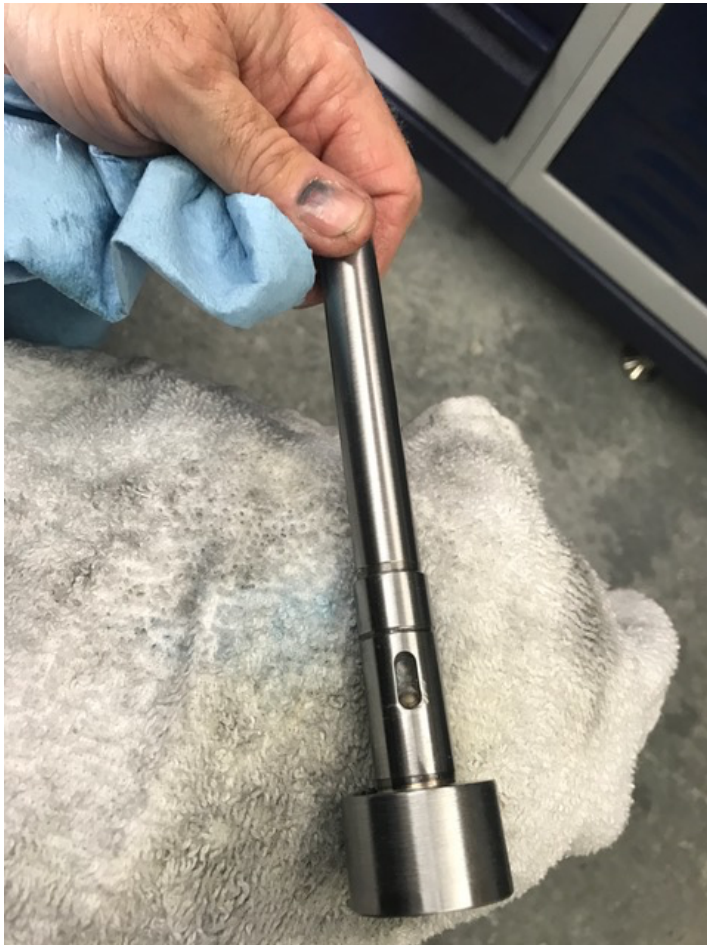
Once disassembled, I found that all the gears and both shafts had been heavily coated with overspray from the factory paint job. I cleaned all that up and polished the shafts:

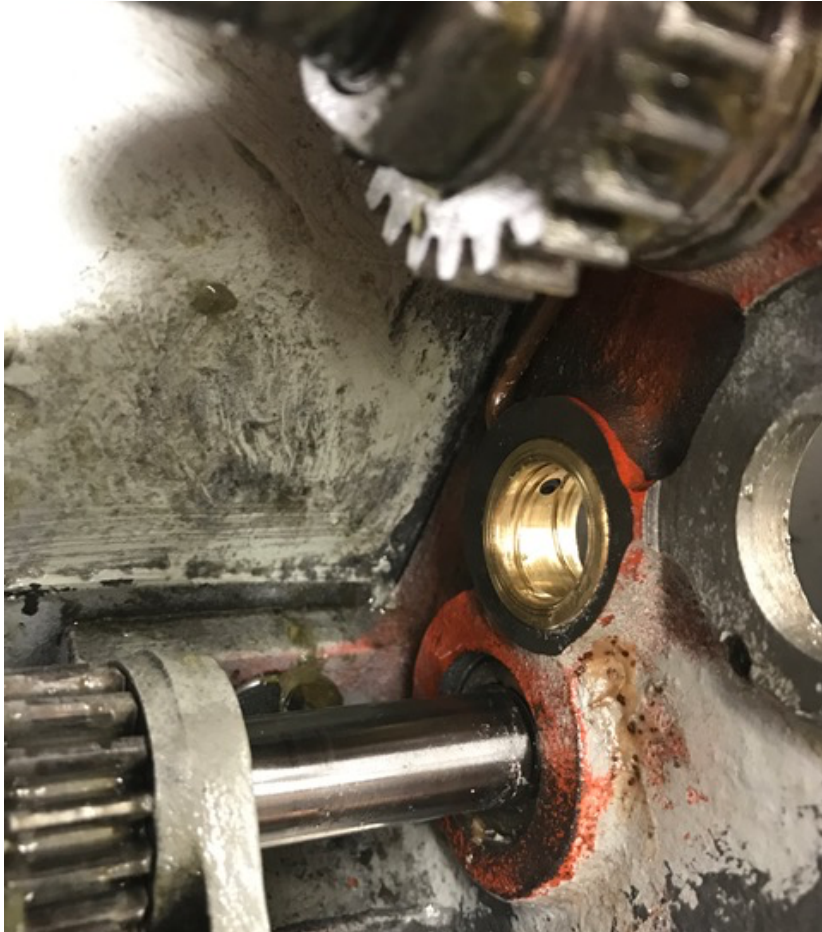
The shaft is supported with a bronze bushing with oil galleries around the inside of the bushing. That bushing, and the part of the shaft that was in the bushing was gunked up with something that looked like tar. This was the source of the friction that was keeping the shaft from spinning freely, and which got worse as the bearing surfaces got hot. I suspect that tar-

like gunk was either additional paint overspray from the factory, or cosmoline rust inhibitor applied to the machine before packing. I don't know what else it could have been.

By the way, that bronze bushing is lubed by oil coming down from the galleries above via a small copper tube to the back where you see the hole in the bushing.

The shaft to bushing tolerance is VERY tight - I ended up using a hair dryer to heat the bushing and an ice cube on the shaft and pounding as best I could to get the shaft removed. It took almost 2 hours to get it out. But I did get it cleaned up and polished with ultra-fine Scotch-Brite, and this is how that bushing looked afterward:

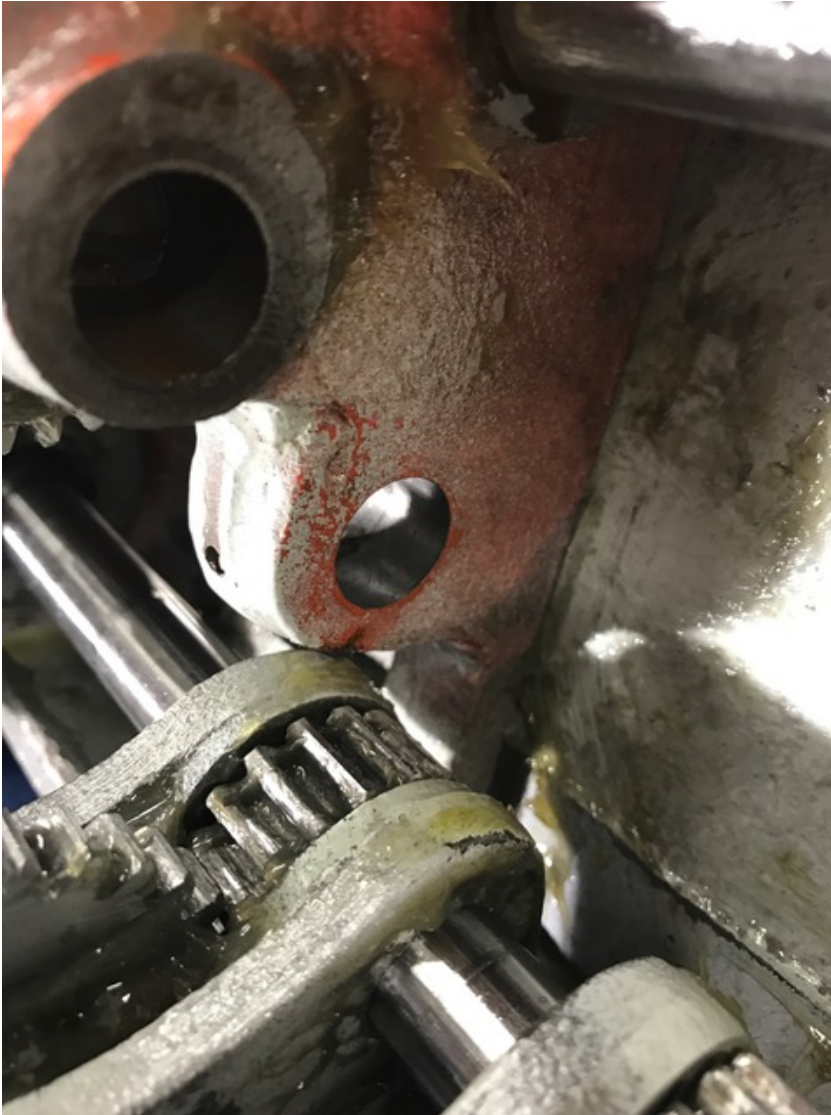
I also discovered that the shaft that drives the feed rod has no bearing on the left end (just a bored hole in the casting web). This is the hole in the casting web at the opposite end of that shaft - no bushing or bearing here:

As you can see in the photo above, there is lots of factory paint overspray inside that gearbox.

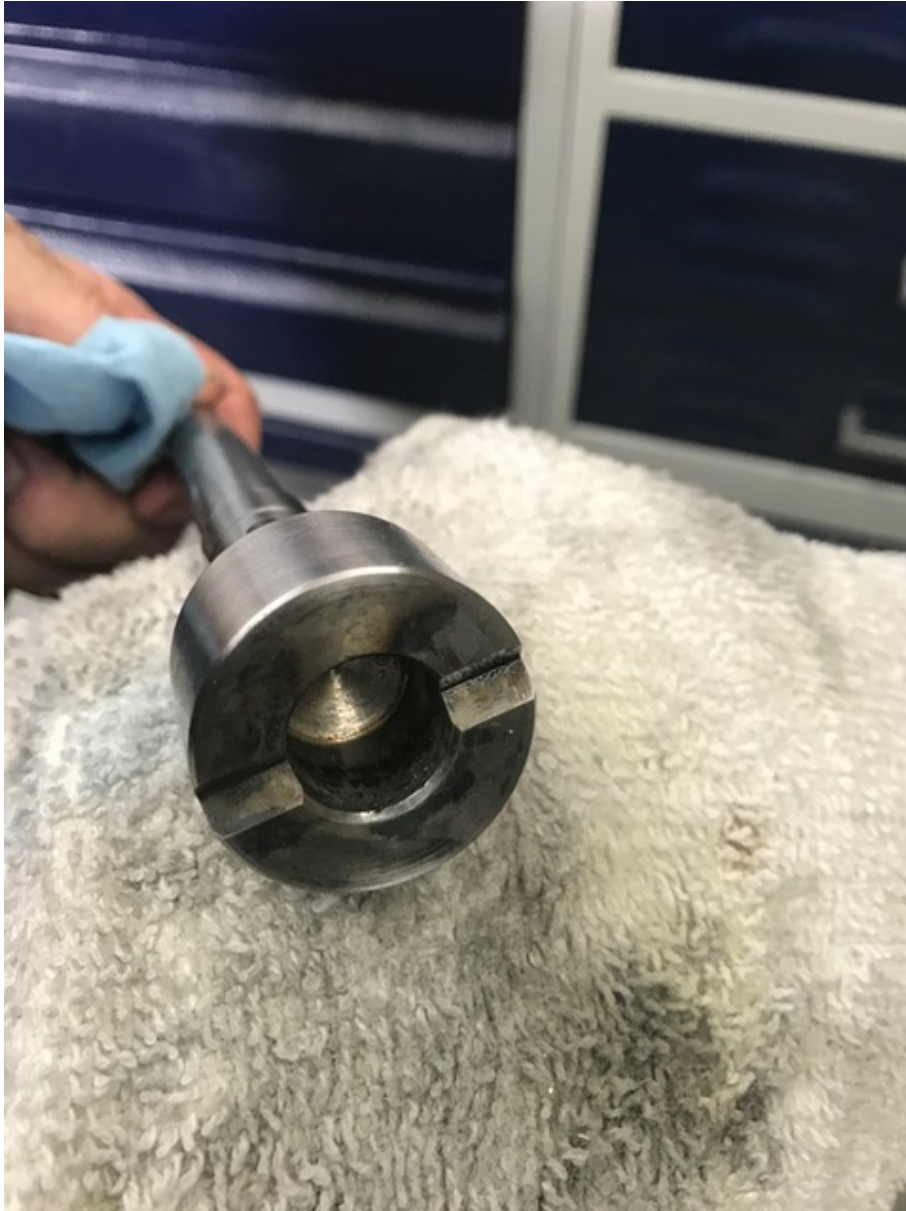
The photo below shows the end of the drive shaft that couples to the feed rod. The end of the feed rod itself has a fitting with two ball bearings backed by springs that tension this clutch mechanism. I was able to get this clutch adjusted so that it now works properly and will drive the carriage under load, but give way and spin if I grab hold of the carriage positioning handwheel and force it to stop.

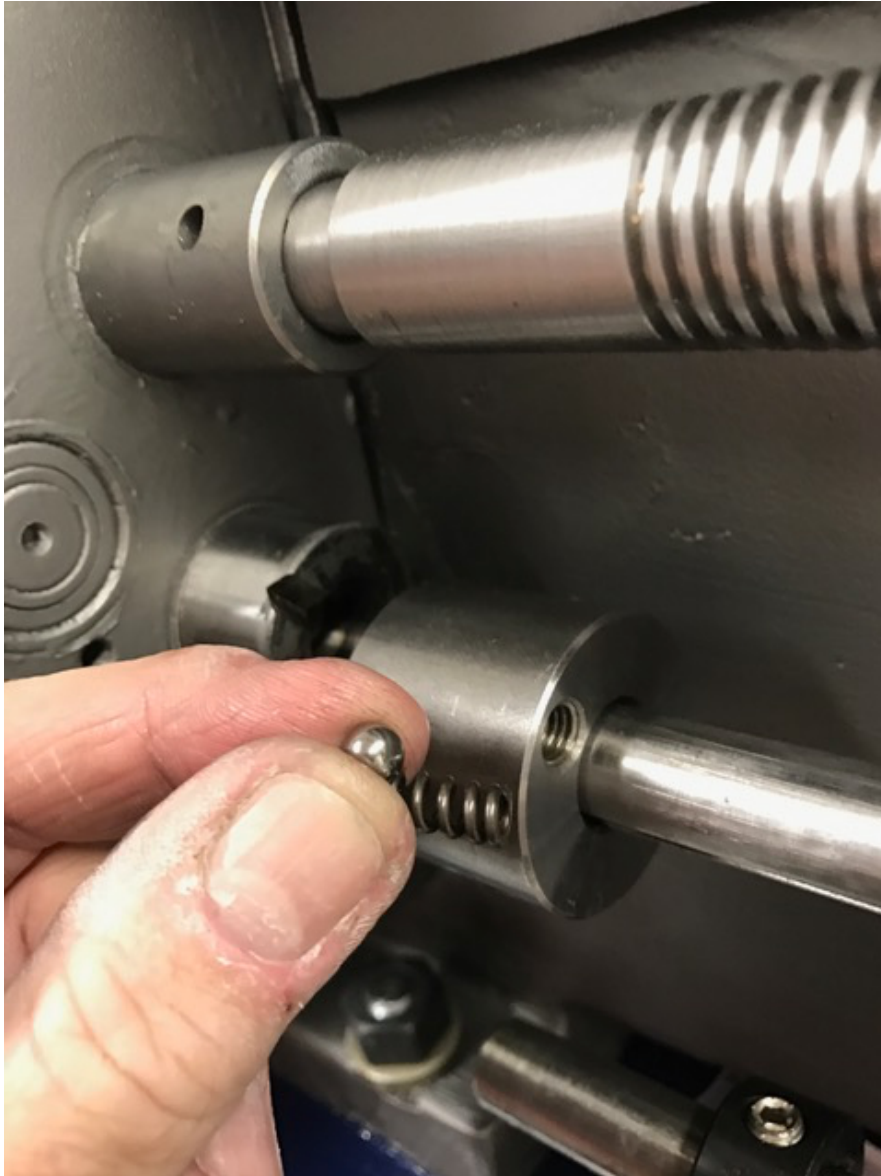
The outside end of that shaft (with the two V-shaped notches) is the clutch (ball bearings on springs) that will give way if the feed shaft is stalled downstream.

The clutch comprises a pair of spring loaded steel balls bearing on a detent disc driven by the Norton gear-box. Spring pressure is adjusted by two set screws on either side of the feed shaft, arrowed. Setting the spring pressure is a process of aiming for the best compromise between too high and too low, which might mean unexpected stopping for no good reason.
